Field Report for Airborne Data Collected In Support of US EPA Region VI ExxonMobil Baytown Fire 31 July 2019

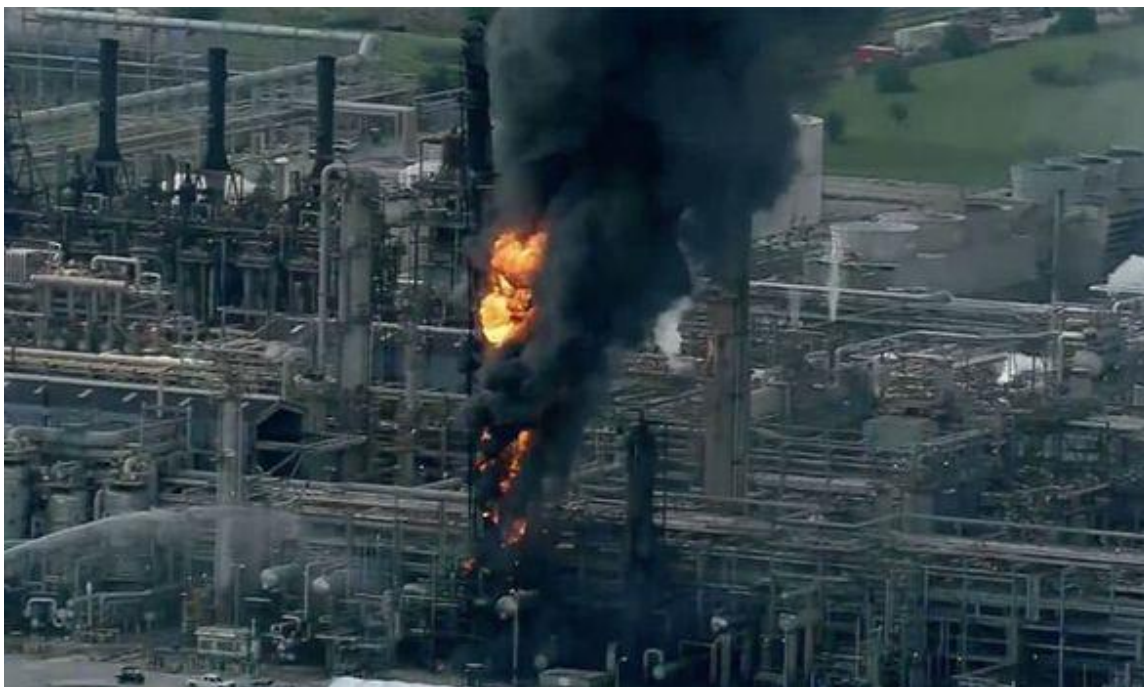
Figure 1. ExxonMobil Baytown Fire (Source: express.co.uk)

On 31 July 2019 an explosion and subsequent fire was reported at the ExxonMobil Baytown refinery located west of the city of Baytown, TX. Local reports indicate that shortly after 1100 local an explosion and resulting fire was observed within the olefin unit at the ExxonMobil Refinery and Chemical facility. Up to 37 minor injuries were reported as a result of the accident and local media provided images and video of the unit on fire and a towering column of black smoke being emitted from the site. At 1425 local, the facility reported the unit had been isolated (blocked in) and plant personnel were spraying water on the impacted unit. The geographical coordinates of the facility are 29.7584N, 95.0067W (figure 1).

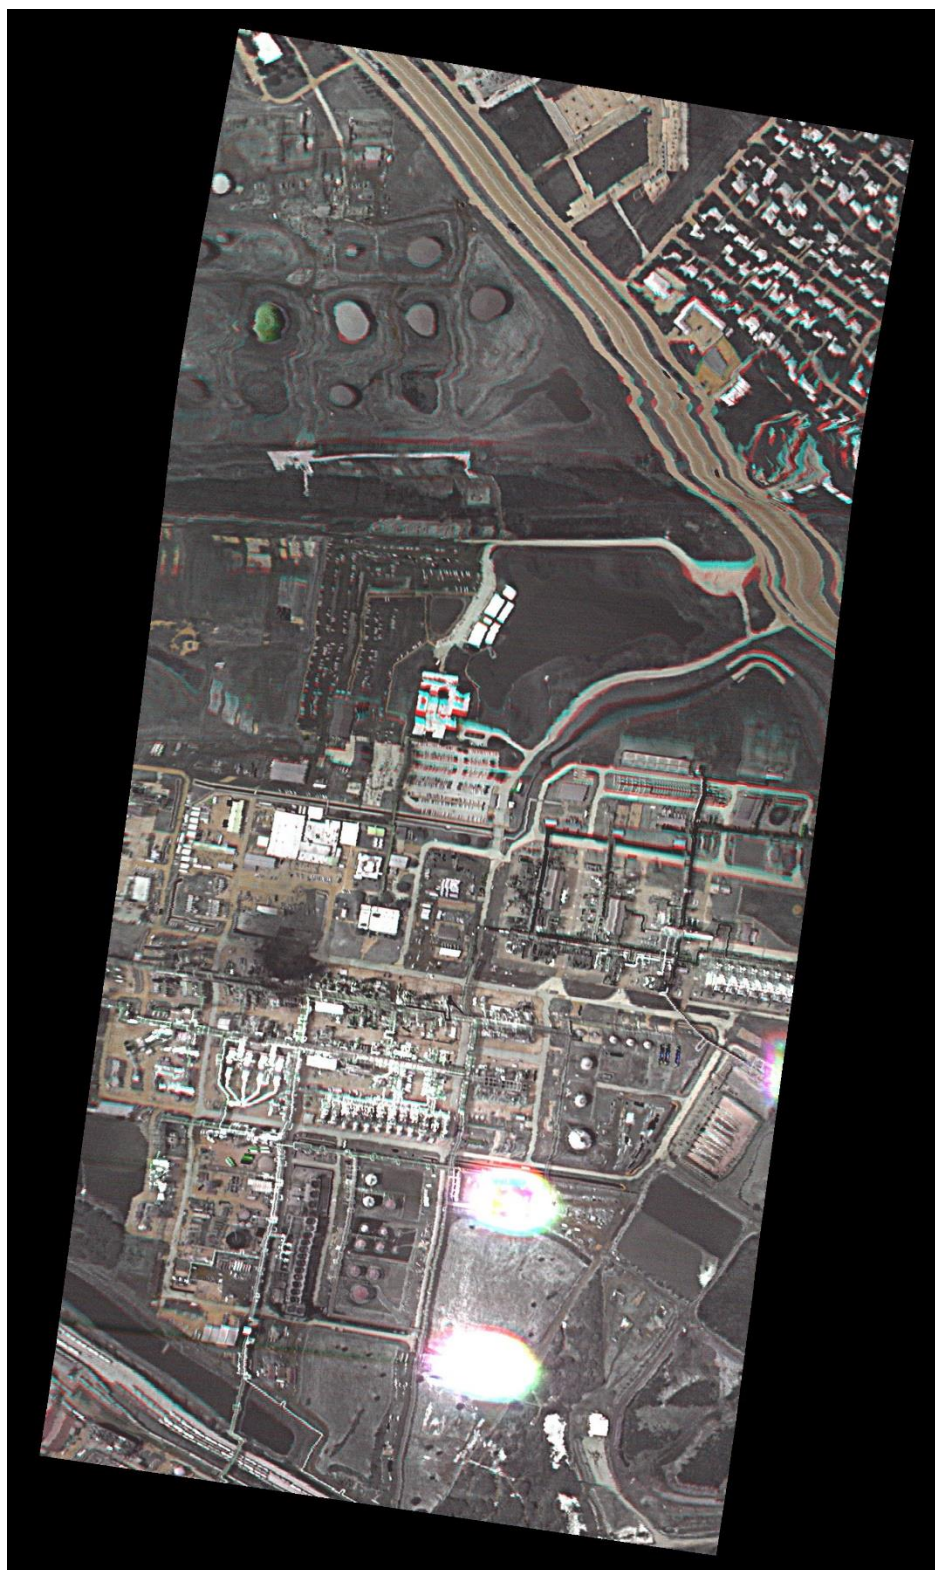
Figure 3: – 3 band IR image, ExxonMobil Baytown Fire, Pass 2

A total of 1 test and 11 data passes were made in the proximity of the fire and an infrared line scanner image was generated for each pass. Figure 3 shows a typical 3-band infrared image obtained from data collected for Run 2. This image was generated by flying directly over the facility. The two white spots on the lower portion of the image are hot signatures from operating flares. Area west of the large building in the image is the hot signature of the fire. No observable plume is present confirming that the pilot reports of a light plume is accurate.

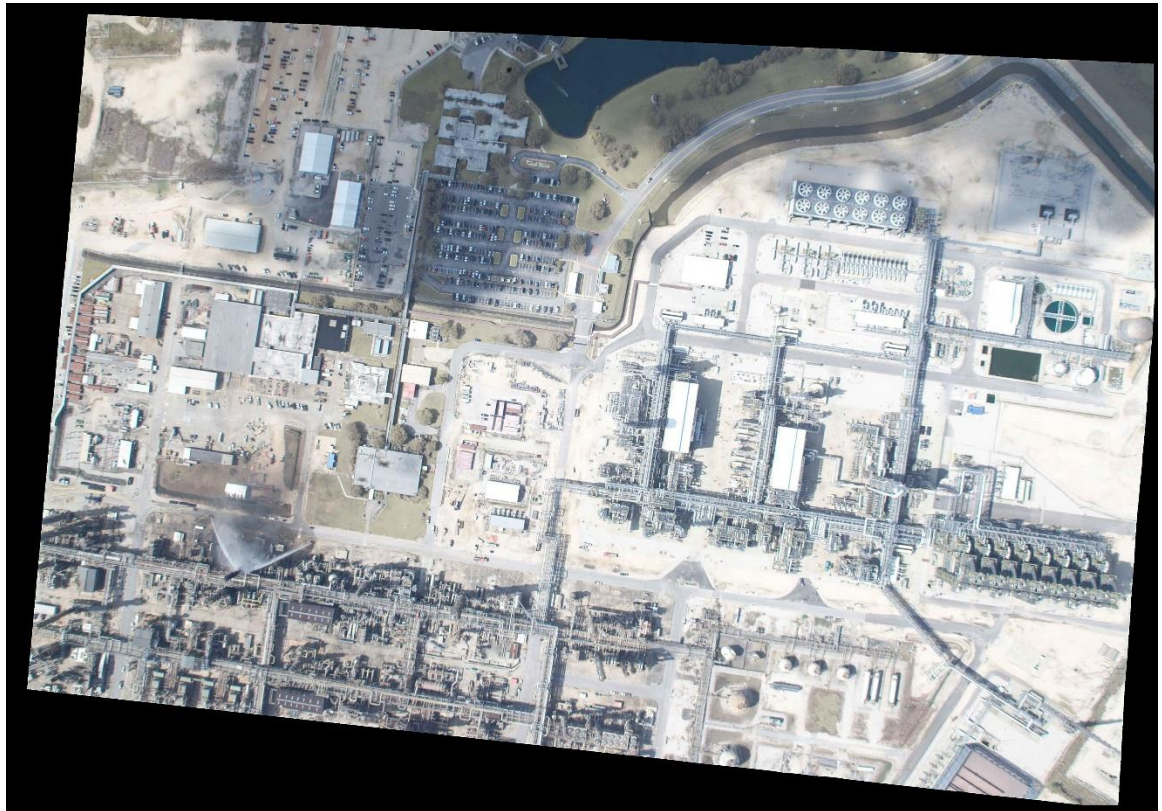
Figure 4: Aerial Image of the ExxonMobil Baytown Fire

A full set of high resolution aerial digital photography were collected as part of the flight. Figure 4 shows a representative image collected as part of each pass. Examination of the image shows two firewater streams being sprayed on the unit in the lower right quadrant of the image. The frame illustrates that the fire was extinguished and was generating no significant visual plume at the time of the image collection.
